9.2 Overhauling the Birmingham Scots

OVERHAULING THE BIRMINGHAM SCOTTS

TALE OF WOE

Restoring a Brum (part 1)

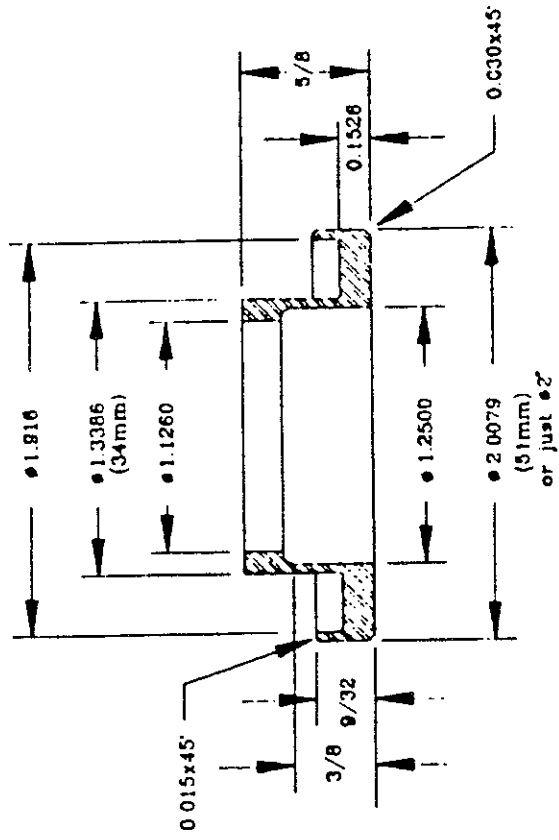
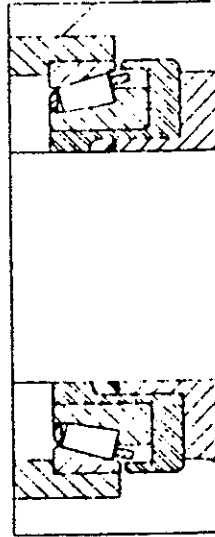
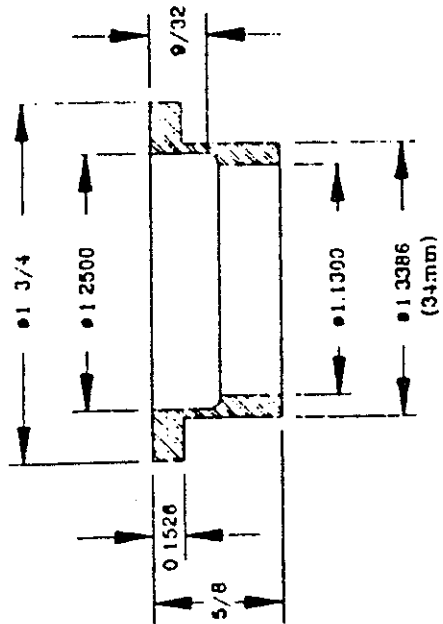
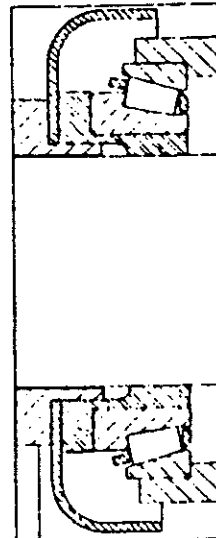
Last instalment on the Brum restoration I mentioned I wanted to replace the steering headrace bearings. According to Ian Pearce, these were not available and I would have to find a substitute. I have come across one, and I thought others might be interested if they have not already found their own replacement. The bearing is a taper roller replacement unit for Earles-forked BMW machines, which originally had a loose ball bearing similar to the Brum. I got mine through a BMW parts dealer. The bearings are special, made in Japan. You will not find these bearings at your bearing stockist! A pair of bearings cost me \$50.00. These bearings are very compact in cross section, and may lend themselves to other retrofits.

4. $\varnothing 1.1300$ " through bore on upper adapter is a bit loose on the fork stem, but is the same size as bored in the upper yoke casting. So 'when in Rome...'. Actually making it a tighter fit than the yoke casting could cause problems when the pinch bolt is tightened.
