9.2 Overhauling the Birmingham Scots

OVERHAULING THE BIRMINGHAM SCOTTS

TALE OF WOE

Restoring a Brum (part 1)

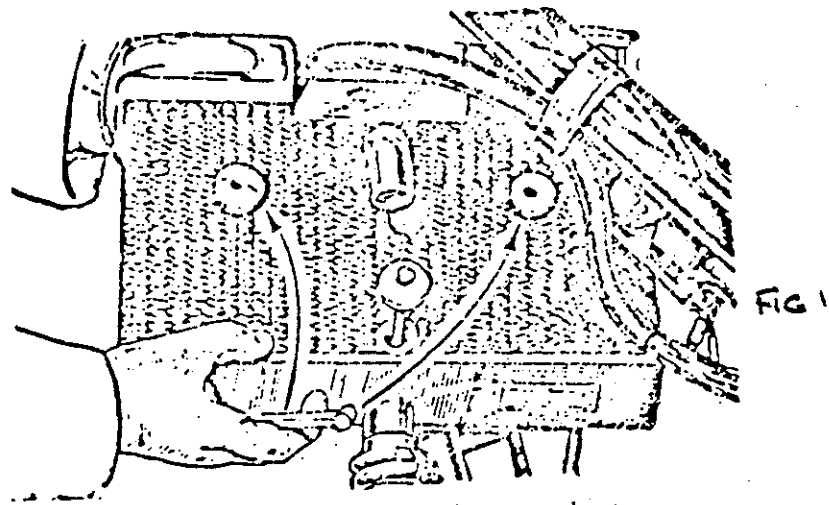
1 Undo the nuts holding the forward seat pillars; take out the tank nose and base fixings, slacken the handlebar clamps and swing the bars and seat out of the way to free the tank. Disconnect the fuel line, take off the radiator hoses and the three radiator mounting bolts (two side and one centre) and the sparking plugs. The radiator can now be gently pulled free.

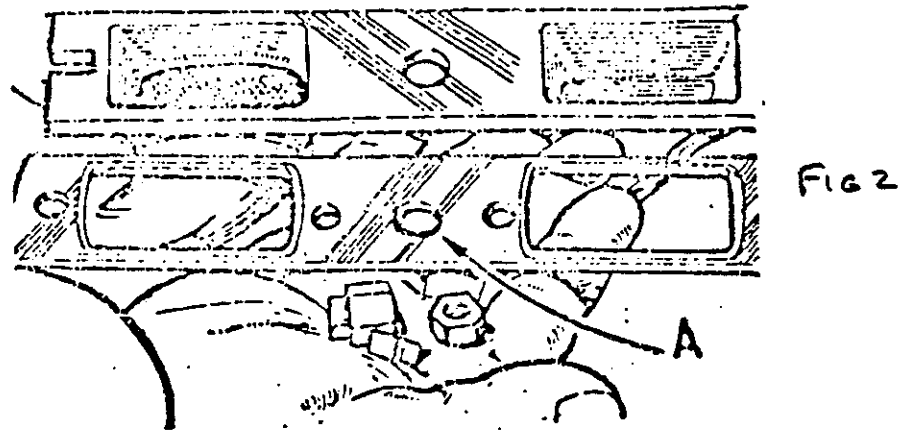
2 The exhaust manifold is located at the block by three studs. It is end-slotted to fit over the studs and is held at the extremities by nuts and washers. The centre stud, which is slightly offset, is accommodated by a similarly disposed hole in the middle of the manifold and a sleeve nut is used. Always renew the gasket and fit is so that the hole "A" registers properly.

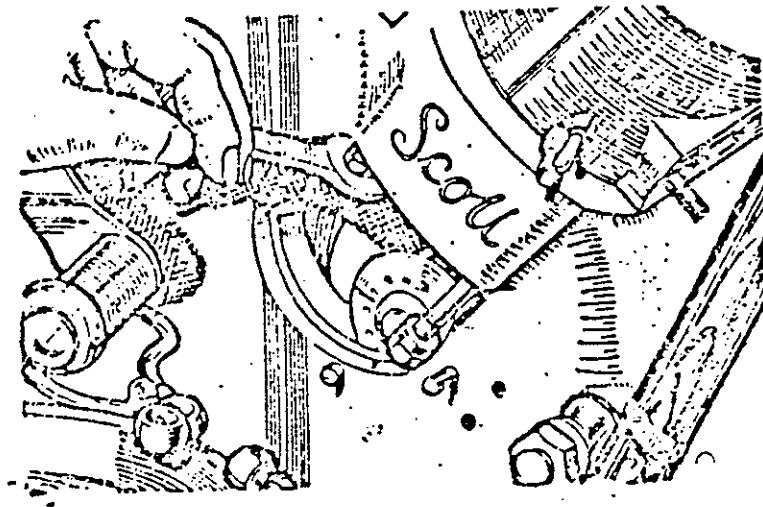
FIG 7

7 Four cylinder retaining studs, two each side of the engine, pass through the crankcase and screw into the cast-iron "pot", clamping it securely to the crankcase mouths. The both hexagons are $\frac{1}{2}$ in. x 26 tpi; a standard workshop spanner can be used. The bolts should fall free, but sometimes stick due to the formation of carbon at the face joint.

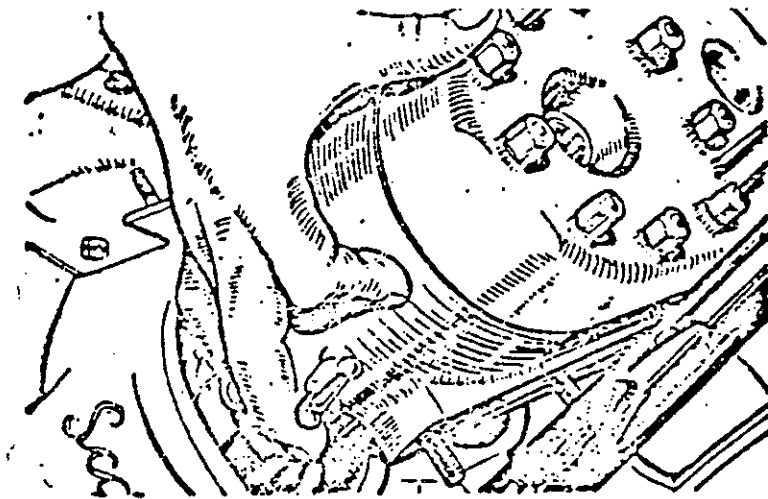
FIG 8

8 On the engine used for demonstration, the block was a very tight fit and the manufacturers emphasised that care must be taken in breaking the joint. Leverage with screwdrivers is taboo and a rawhide hammer, if it is used, must be applied only gently. The final solution in this case was to replace the plugs and spin the engine so that the block lifted on compression.

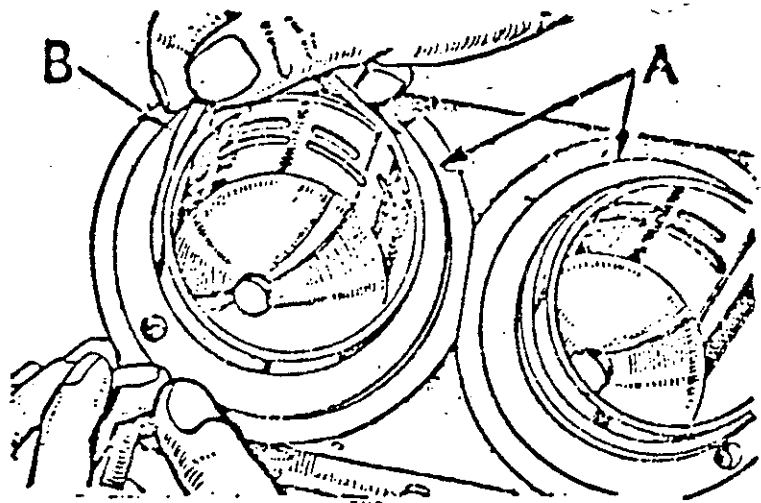
Fig 9

9 As the block lifted, it will probably damage extensively the paper gasket "A" and the Neoprene base rings "B". A new set should be fitted each time the cylinder base joint is broken. Unless tuning with a view to altering the compression ratio, it is neither necessary nor desirable (say the manufacturers) to take off the cylinder head. All the scouring necessary can be carried out from below.

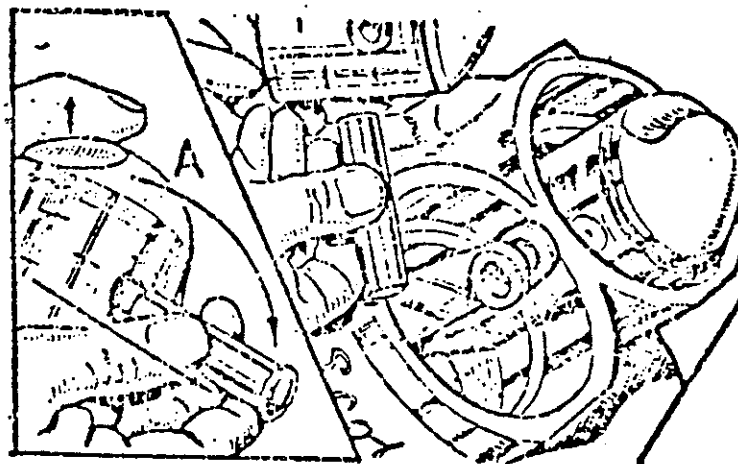
Fig 10

10 Turning to the pistons, note that each gudgeon pin embodies a flanged end-pad which should be on the outer side. The generally good condition of the demonstration engine made it possible to pull the pins free by hand. This arrangement is seen in the insert, where "A" indicates the outer location of the flange as the pin is withdrawn. The small-end cut-away facilitates lubrication.

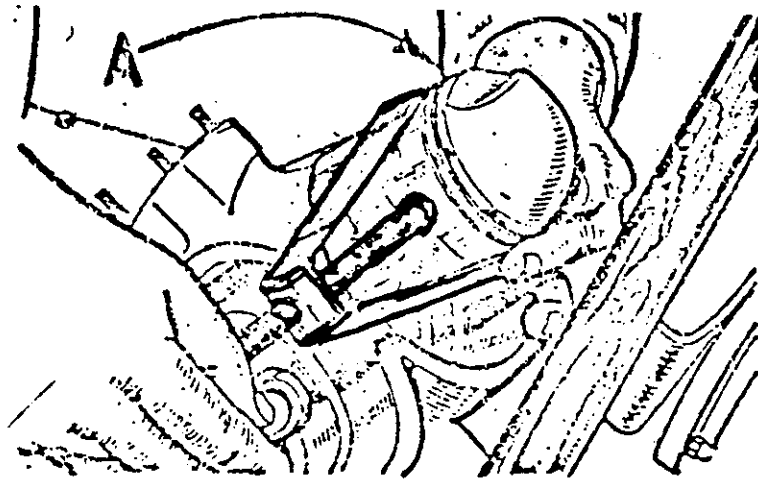
FIG 11

11 An alternative method, if the pin is a tight fit, is to employ a conventional gudgeon-pin extractor. This gadget should be employed in preference to tapping the pin free. Note that the expelling action is still from the centre, where the pin is unflanged, towards the outer boss. Replace each pin from the outer side and note that the steep part of the deflector crown "A" is to the rear.

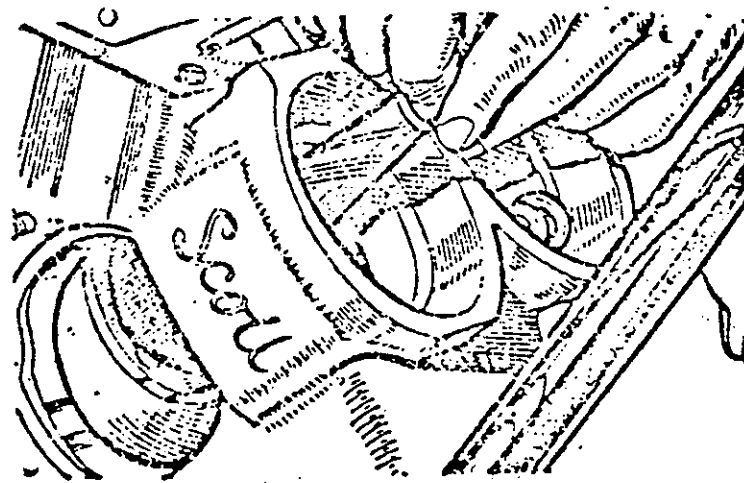
FIG 12

12 This is as far as a top overhaul need usually be taken. It remains only to clear away carbon from the ports, the head hemispheres and the exhaust system and then to reassemble. The demonstration unit had run for more than five years without attention to the bottom end. The routine up-and-down test showed no defect there but, in the interest of next weeks' instalment of this article, the crankshaft assembly was also dismantled.

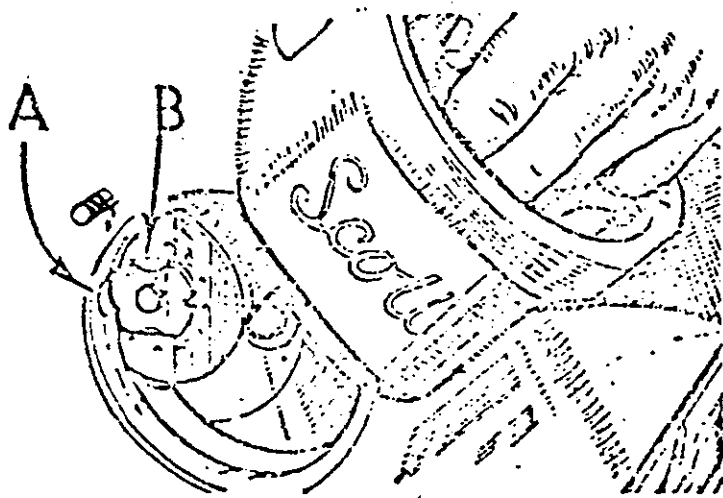
13 Move the connecting-rod assembly so that the crankpin comes round to the half-moon cut-away in the crankcase door, as at "A". The lock-washer "B" can be used twice by turning it through 180°. A special peg-tool (see No. 2) slackens the crankpin screw (left-hand thread on right side of engine and vice versa). Alternatively, start the screw with a hammer and soft drift.

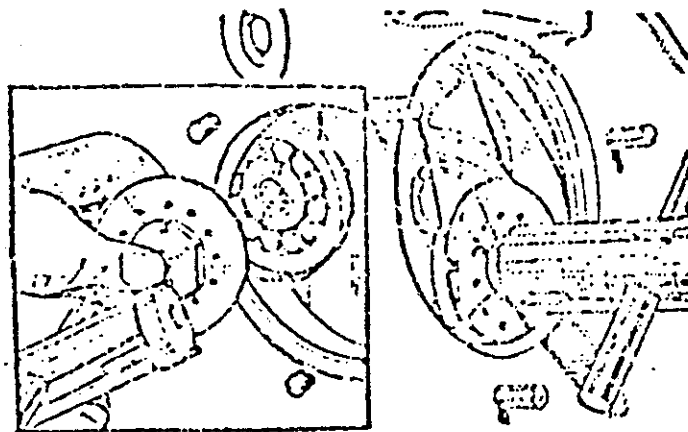
14 On early models no lock-washer was fitted but, as a result, the bearing assembly could slacken in the event of the engine temporarily running in reverse—usually a result of over-advanced ignition. To avoid risk of trouble, the fitting of a lock-washer to the older models is advised. Sketches show the peg-tool and its application.

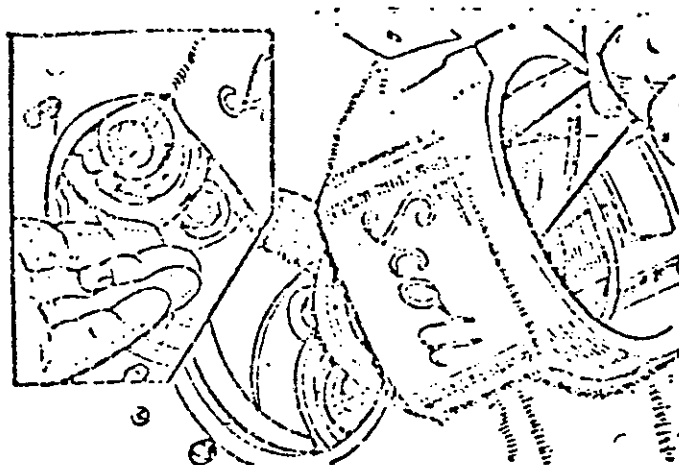
15 Taking away the crankpin screw and plate assembly, releases the connecting-rod so that it can be withdrawn. Two slots in the crankcase mouth provide clearance for the con-rod to be tilted while the big-end bearing (12½ x ½ in. Hoffman rollers) comes away (inset). Scoop out the rollers and inspect for wear.

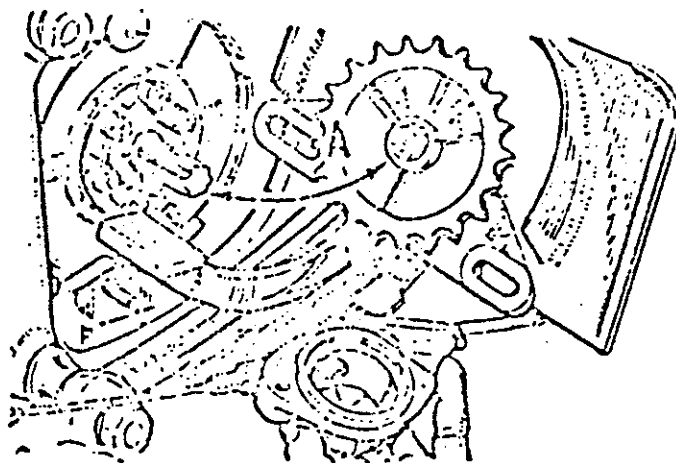
16 Before the crankshaft assembly and central flywheel can be dismantled, the primary and secondary transmission must come away. Take off the rear chain, the speedometer-drive unit and the outrigger housing which carries the final-drive sprocket on a self-aligning ball-journal bearing. Note that the sprocket splines on to the gearbox mainshaft "A".

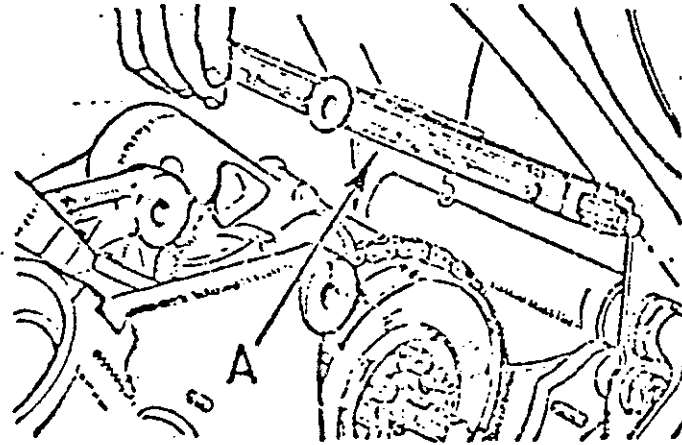
17 Further dismantling involves removal of the oil tank, retained by two $\frac{1}{4}$ in. bolts and supported below by two rubber buffers. Take off the top cover plate of the flywheel and primary chain compartment; extract the through-stud connection and pull up the tubular cross-member "A" which acts as an oil-tank platform and a support to the duplex main frame.

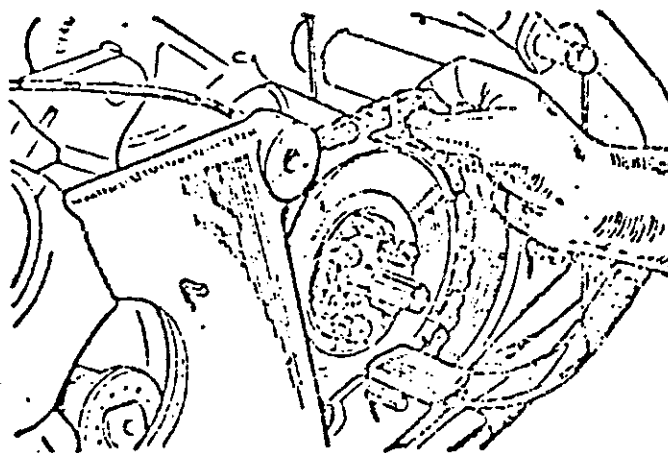
18 Slacken the primary drive by moving the gearbox fully forward. The box is to be removed, therefore slacken the two $\frac{1}{4}$ in. x 26 tpi anchorage pins. The primary chain can now be lifted off the clutch sprocket; alternatively, the split link can be disconnected. The gearbox is now free to be taken out of the frame.

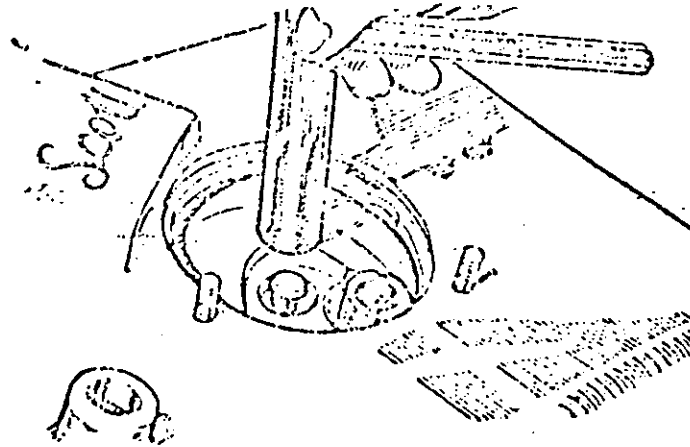
19 Take out the crankcase; remove the main bearing oil pipes. Slacken the left-thread nut on the through-bolt in the right crank. The bolt-head on the opposite side is right-hand threaded. Partially slackening the bolt and striking the hexagon head is one way of dislodging the right-hand crank assembly from its taper fit in the flywheel.

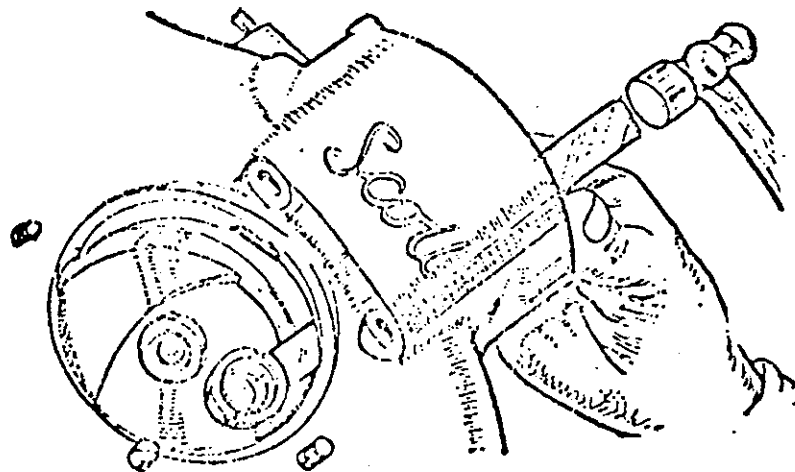
20 An alternative method of breaking the taper fit is illustrated. When the centre bolt is extracted, use a hammer and drift to tap the crankpins and break the taper-fit torsionally. Work carefully to avoid damaging the surrounding crankcase metal. Half-a-dozen taps are normally sufficient to break the taper.

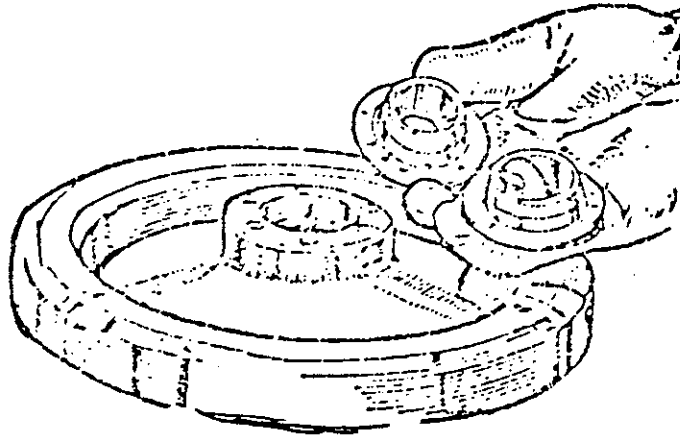
21 With the crankshafts removed, the flywheel and primary drive sprocket (not visible in this sketch) can be withdrawn. Keying into the boss are right- and left-handed packing glands; these should not be reversed when re-assembling because each is precision-drilled to provide correct lubricant inflow at the induction phase.

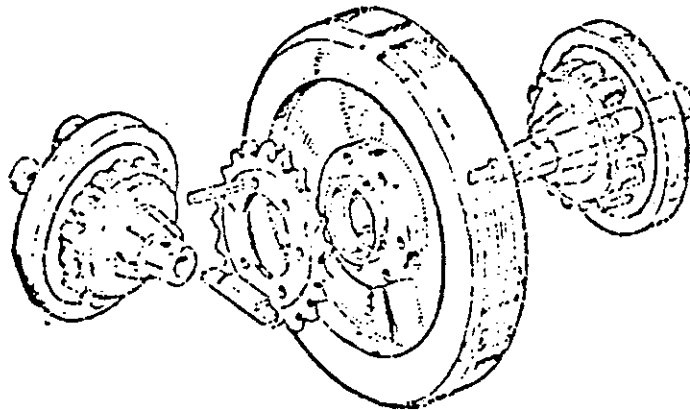
22 The crankshaft, centre flywheel and primary chain sprocket in extended form. Rigidity is preserved by the narrow dimension of the assembly when nipped up in the flywheel centre taper, where it is secured by a common key and through-bolt and nut. Main bearings are $\frac{1}{4}$ x $\frac{1}{4}$ in. rollers (15 each side) running in races pressed into the crankcase inner walls.

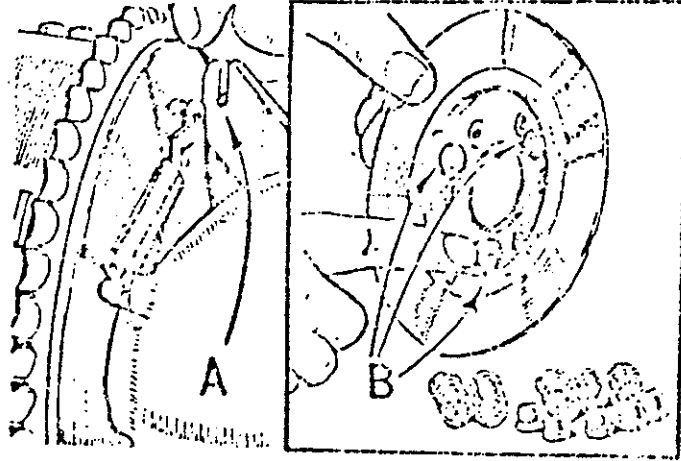
23 Normal clutch maintenance consists of adjusting to establish a minimum $\frac{3}{16}$ in. free movement at "A" when the cable is in position. The clutch is operated by a quick-thread mechanism and the three slot-headed studs and locknuts "B" provide basic adjustment. The clutch runs on $\frac{3}{16}$ in. x $\frac{3}{16}$ in. (30) caged rollers and there are four plain and four friction plates in the assembly.

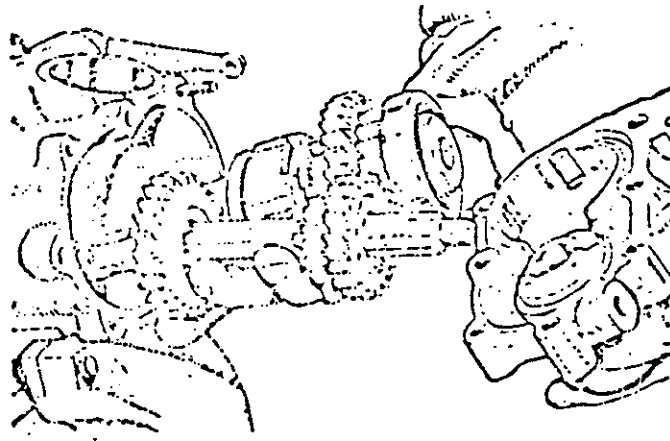
24 To get at the gearbox interior, take off the end-cover, held by four sleeve nuts and three dowels, complete with k/s and gearchange mechanism. Take out the oil-level plug; this gives access to the main bearing which is now tapped free. Apply a mallet to the splined end of the mainshaft to expel the gearbox "internals" complete with end-cover. Normally the high gear wheel drops down into the shell.
