5.8 Electric Horns

THE SCOTT-KLAXON HORN

Mike Keighley

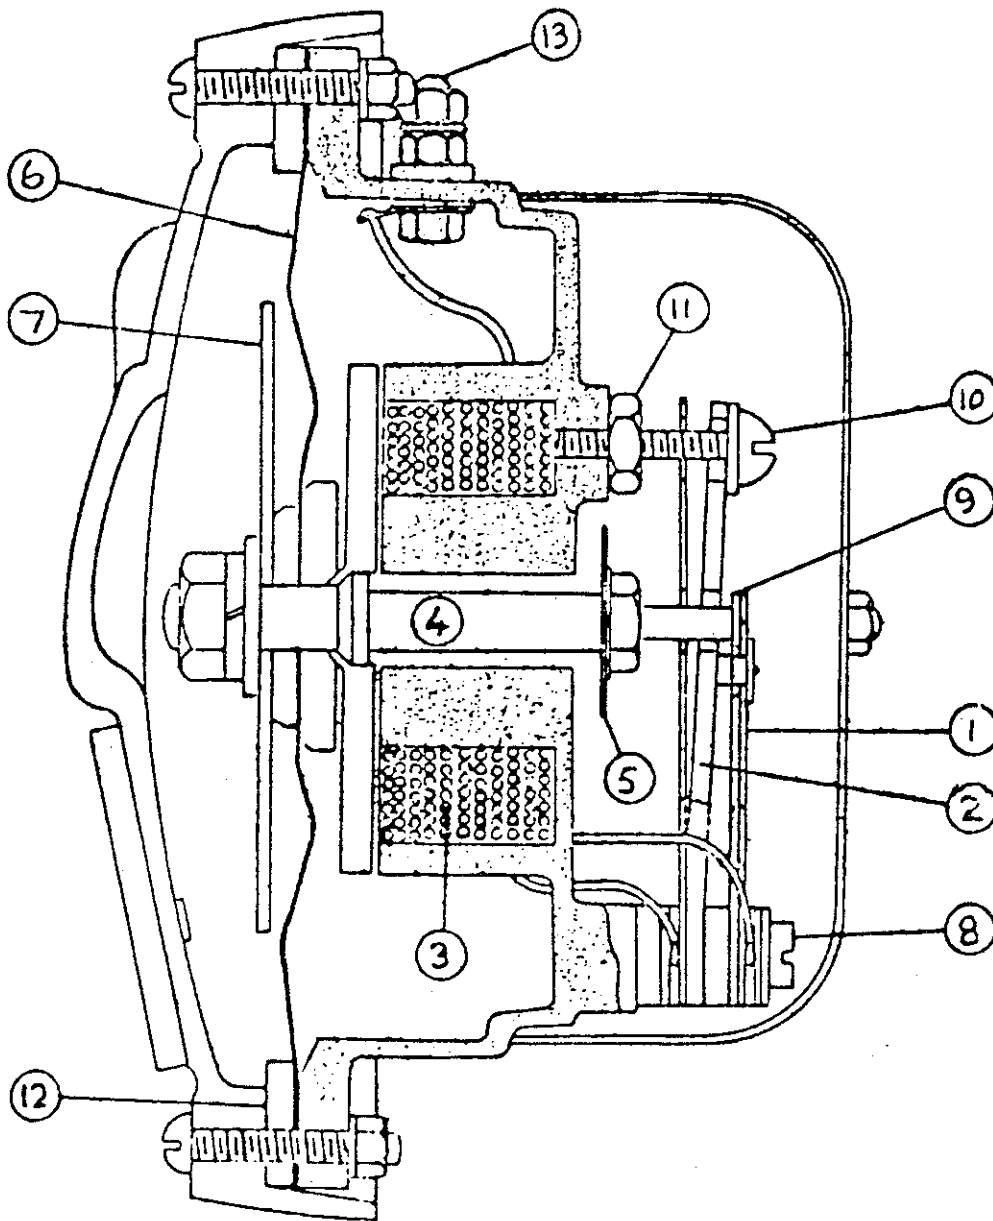
Figure 1 shows a part-sectioned drawing of the horn, on which some lines have been omitted in the interest of clarity. Before the horn-button is pressed the two contact breaker fingers (1) and (2) are in the closed position. When the horn button is pressed, current flows through the contact breaker and the coil (3), which is energised. This moves the armature (4) towards the contact breaker and in lifting the top finger (1) breaks the current flow. The coil de-energises and the spring (5) (the securing screws of which are not shown in the drawing) and the diaphragm (6) pulls the armature back to the original position, thus closing the contact breaker and whilst the horn button remains pressed, repeating the cycle. The diaphragm (6) and the tone disc (7) amplifies the noise produced by the rapid movement of the armature to provide the horn sound.

To gain access to the rear of the horn remove the dust cover, which is secured by a single 2BA nut. Before carrying out adjustments check that all nuts and screws are tight and that the points of the contact breaker are in good condition and clean. If necessary, access to the points is achieved by removing the screws (8) (only one is shown in the drawing, the other is behind it, out of sight) to partially dismantle the contact breaker stack. Check that the Paxolin leaf (9) is in good condition, particularly at the point where it is struck by the armature. Adjustment is effected by turning the screw (10), secured by lock-nut (11), clockwise to open the points and anti-clockwise to close. Turn the adjusting screw until a satisfactory sound can be obtained and then, with an ammeter in the test bench circuit, note the current reading which must not exceed 3-4 amps. If the components in the rear of the horn are in order, but a satisfactory sound still cannot be achieved, it is possible that the fault lies in the front. Remove the six bezel screws, the bezel and steel ring (12) together with the nut on the end of the armature. This will allow the tone disc, diaphragm and washer and spacers to be removed; make a note of the order in which the various washers and spacers dismantle and in particular record if there are any shims behind the diaphragm. Check that the diaphragm is sound, free from cracks, splits and excessive corrosion. The coil must be a snug fit in the housing and the two wires related to it in good condition and

not earthing against the body. Ensure that the insulated bushes through which pass the terminal screws (13) (only one shown on the drawing) are present and in good condition. Reassemble in the reverse order, making sure that the armature nut is tight with the spring washer fully closed up. It is important that the diaphragm is evenly clamped up by the six bezel screws and nuts if a satisfactory horn sound is to be achieved. If the original bezel screws are worn out they can be replaced by 4BA stainless, the heads of which will take a polish and look like chrome. If a sound still cannot be produced it probably means that the insulation of the coil has deteriorated to the point of failure, in which case a new coil will be necessary. For most of us this will be a job for the specialist and such services are currently available from advertisers in the classic and vintage motor-cycling press.
